# **Severe Weather Compound Disaster: August 2006 cut-off lows and their consequences in the Southern Cape, South Africa**

**Compiled by  
Disaster Mitigation for Sustainable Livelihoods  
Programme, University of Cape Town  
October 2007**

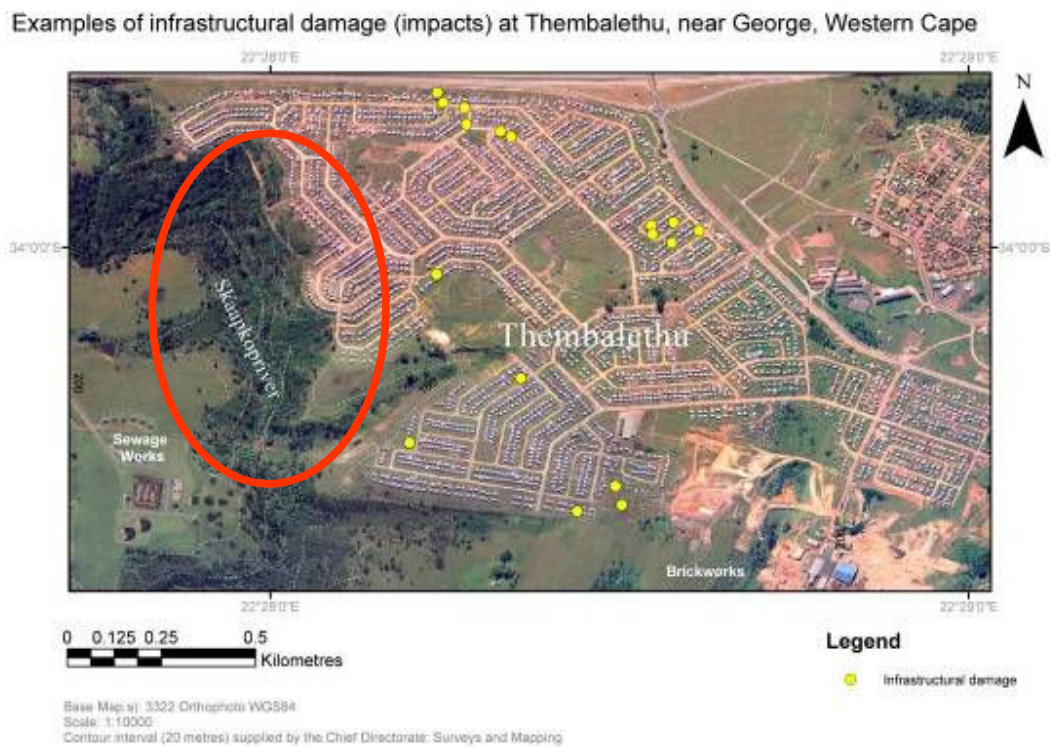
Inadequate or non-existent drainage systems are the major contributors to flood damage in this area (Figure 2.3.4.1.1).

Figure 2.3.4.1.1: Spatial distribution of infrastructural impacts at Thembaletu, near George

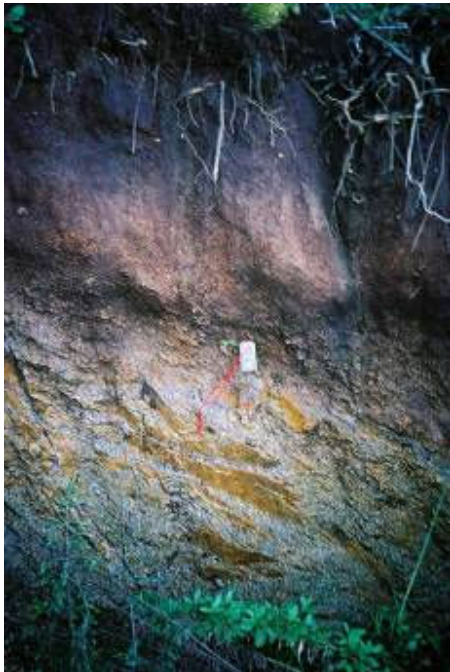
Figures 2.3.4.2.2: Exposed section showing a soil profile.

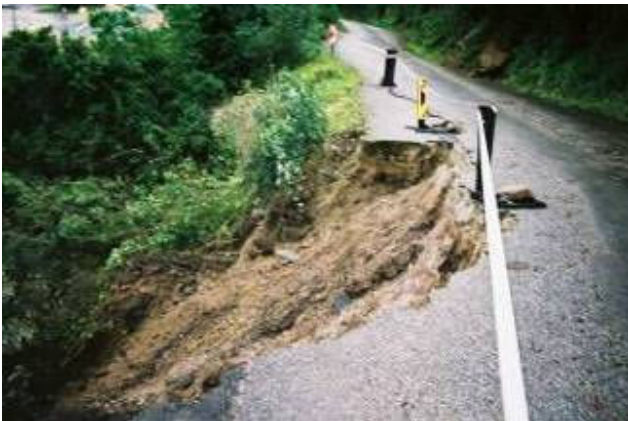
Figure 2.3.4.2.6: Significant damage to a road due to slope failure (mass movement) underneath the road

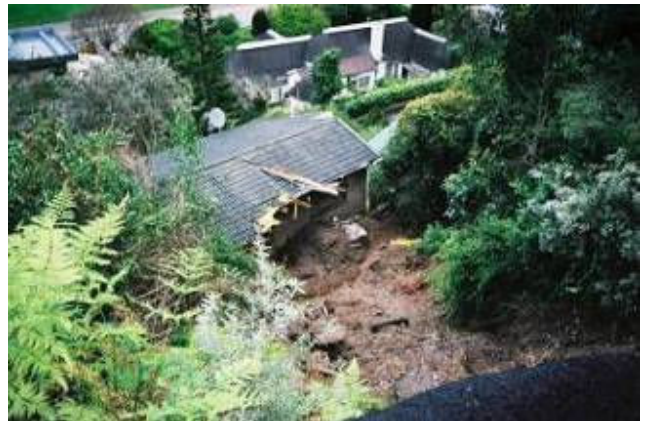
Figure 2.3.4.2.7: Significant damage to a house, due to slope failure (mass movement) underneath the road

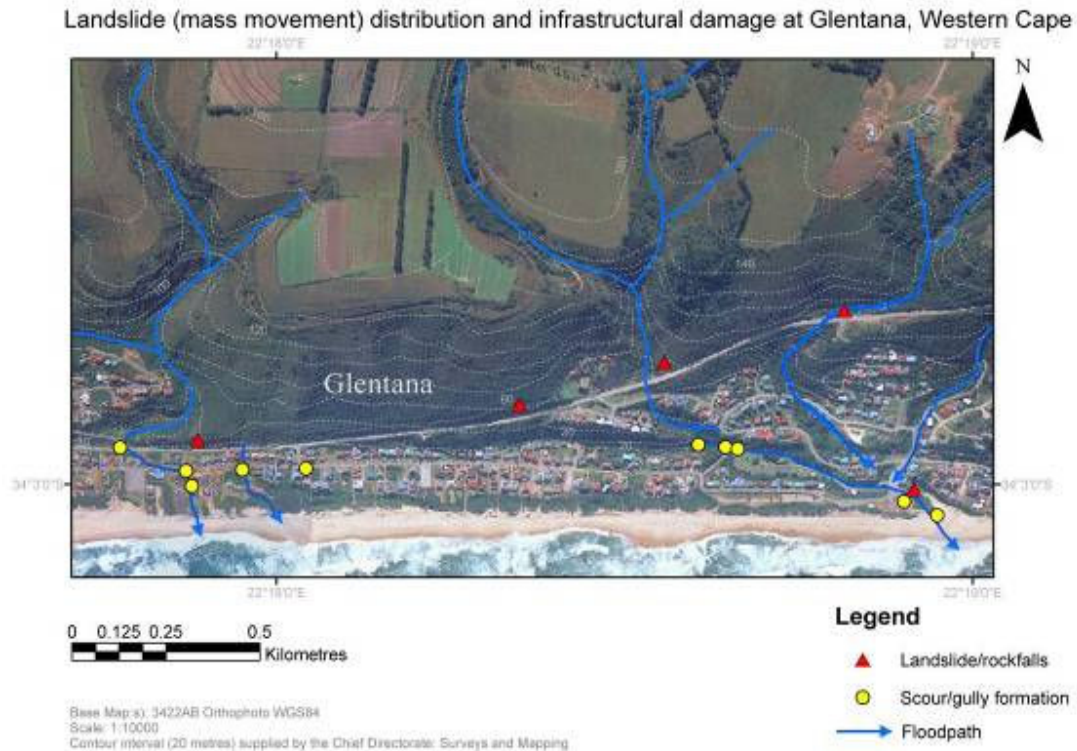
<sup>21</sup> The storm water drainage system, in particular was unable to cope, resulting in the formation of gullies along and through roads.

Figure 2.3.4.3.2: Landslide (mass movement) distribution and infrastructural damage at Glentana, Western Cape. A number of non-perennial streams are highlighted and represent proposed floodways of the surface run-off

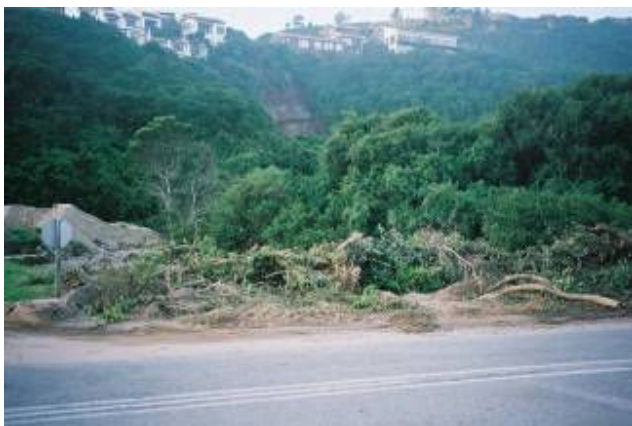
Figure 2.3.4.3.3: Infrastructure (road) built in the floodway of one of the non-perennial streams

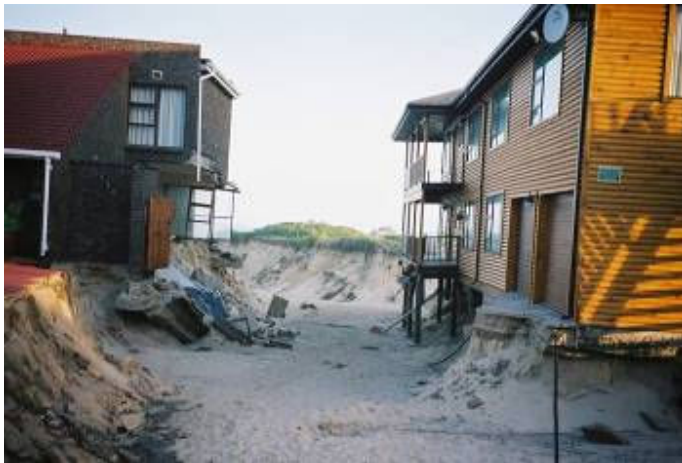
Storm water run-off created a 6 metre wide channel on the coastal dune, by eroding the underlying unconsolidated dune sands. The house on the right was stabilised onto the sand-dune using poles, while the house on the left suffered extensive slip damage

Figure 2.3.4.3.5: Storm water run-off

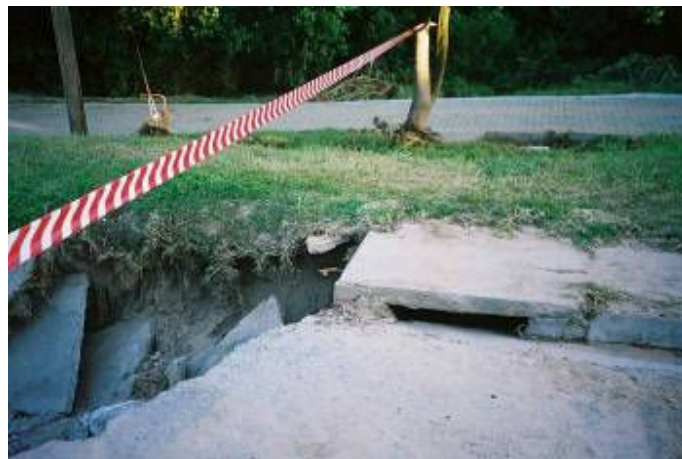
Figure 2.3.4.3.6: The storm water drainage system was unable to cope with the surface run-off

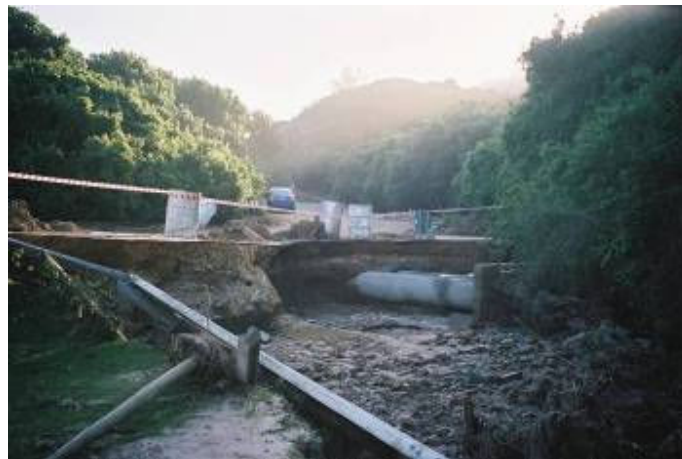
Figure 2.3.4.3.9: A 4 metre wide gully formed along the side of a road

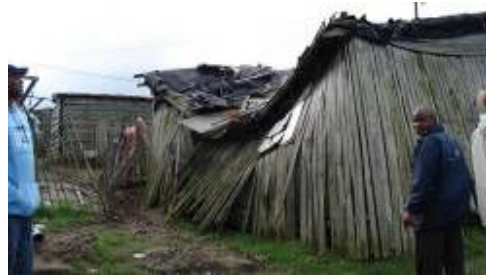
Figure 3.2.3.2.1: A seriously affected informal dwelling, located in a poorly drained area with high water table

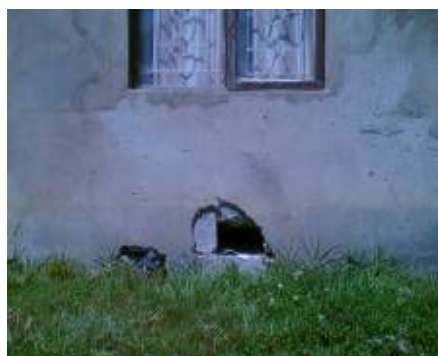
Figure 3.2.3.2.3: A hole made in an RDP dwelling to drain out water

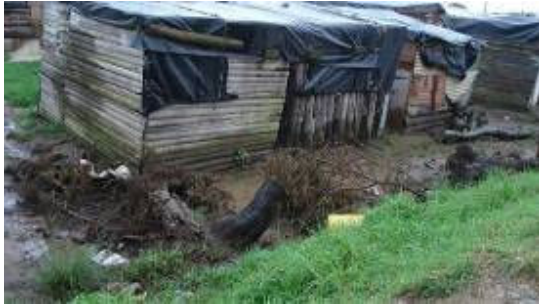
Figure 3.2.3.2.4: Informal dwelling with poor roofing and construction

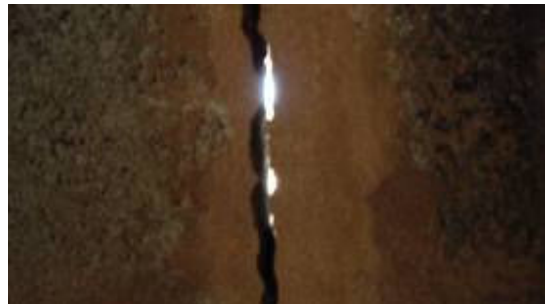
Figure 3.2.3.2.9: Light entering RDP dwelling through cracked wall

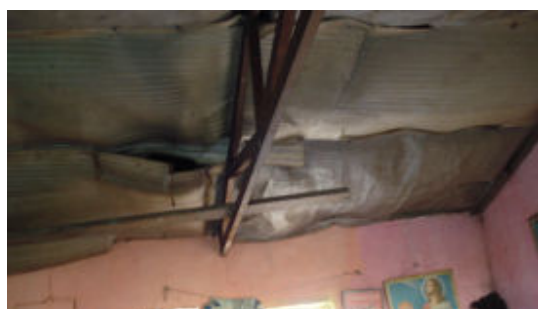
Figure 3.2.3.2.10: Debilitated roof of RDP dwelling sagging from rainwater

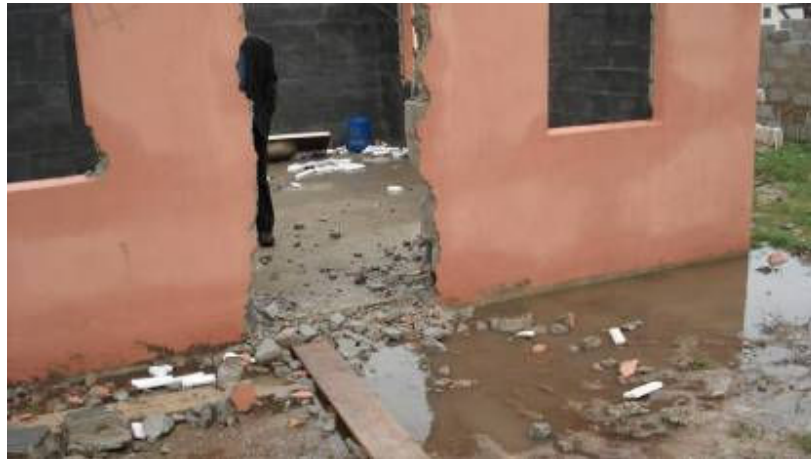
Figure 3.2.3.2.11: Part of the wall of a RDP house washed away by storm water run-off

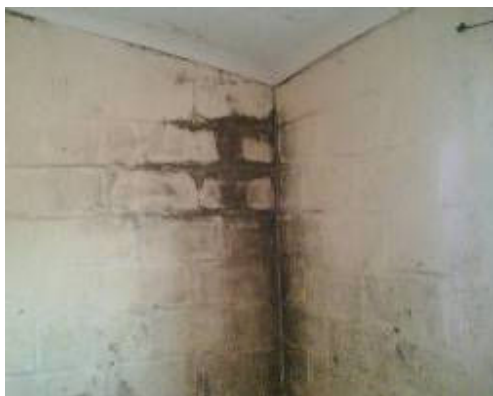
Figure 3.2.3.2.14: Damp and mouldy wall inside RDP dwelling

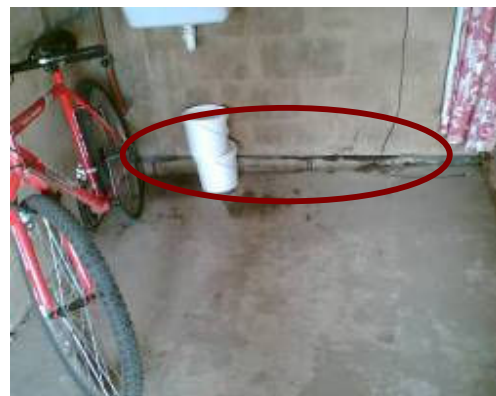
Figure 3.2.3.2.15: Subsided foundation because of high water table

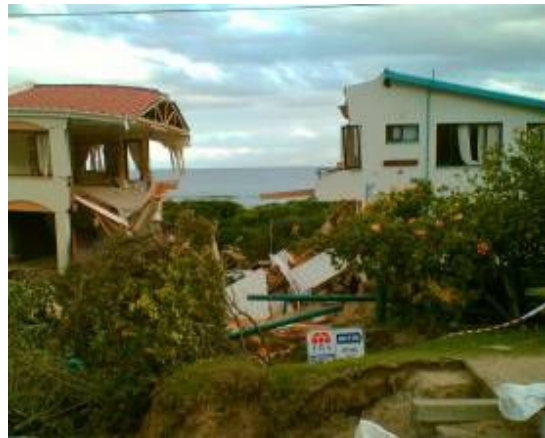
Figure 3.2.7.2.6: House collapsed because of storm water run-off destabilising its foundation

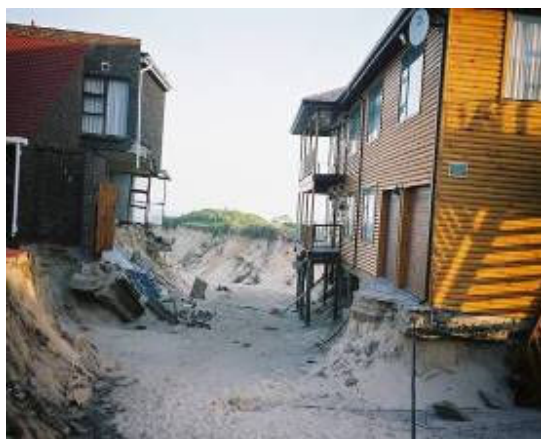
Figure 3.2.7.2.7: Houses destabilised and partially collapsed because of storm water run-off

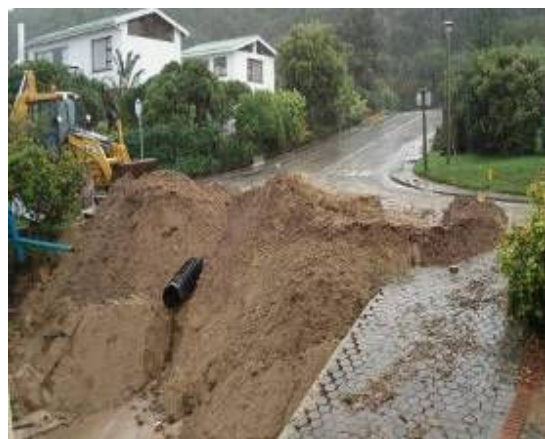
Figure 3.2.7.2.8: Road damaged because of storm water overflowing

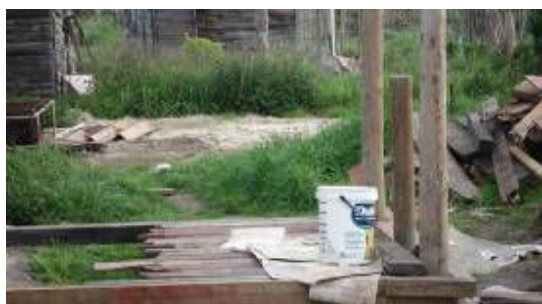
Figure 3.2.8.2.6: Informal dwelling completely destroyed

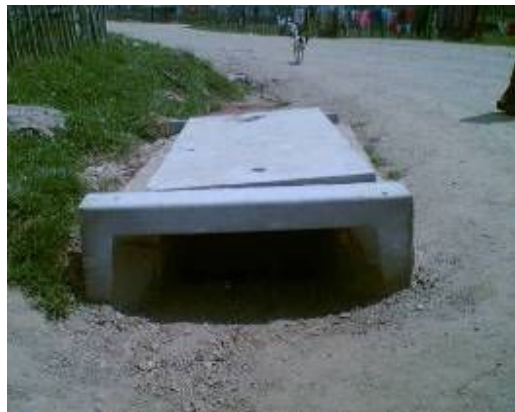
Figure 3.4.3: Newly installed storm water drain
